Identifying and Diagnosing Locations of Ongoing and Future Saltwater Wetland Loss: Mangrove Heart Attack

Charlotte Harbor National Estuary Program Technical Report 16-3 Final 3/9/2017

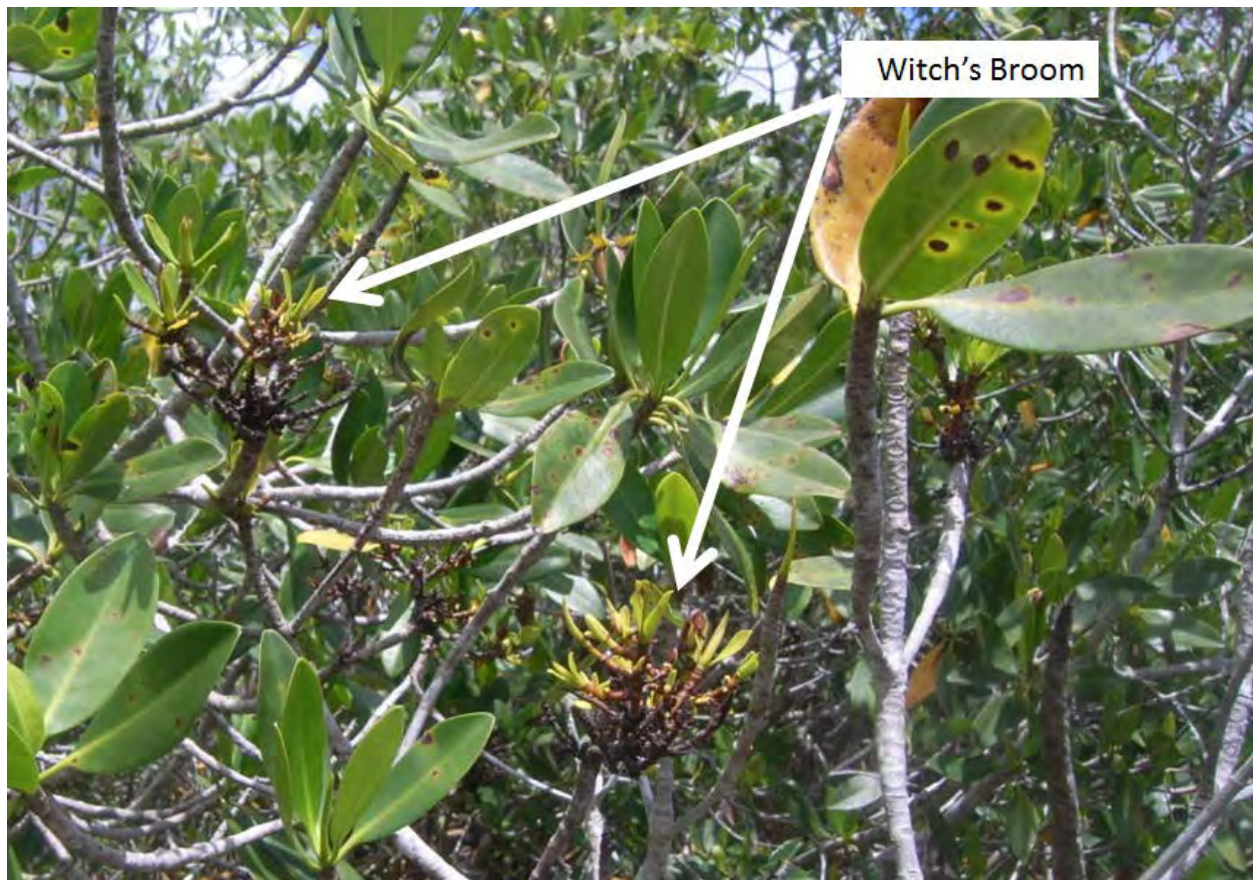
Figure 31: Witch's Brooms in Scrub Red Mangrove Trees

herbicide use, the presence of witches brooms on red mangrove can be considered a symptom of stress.

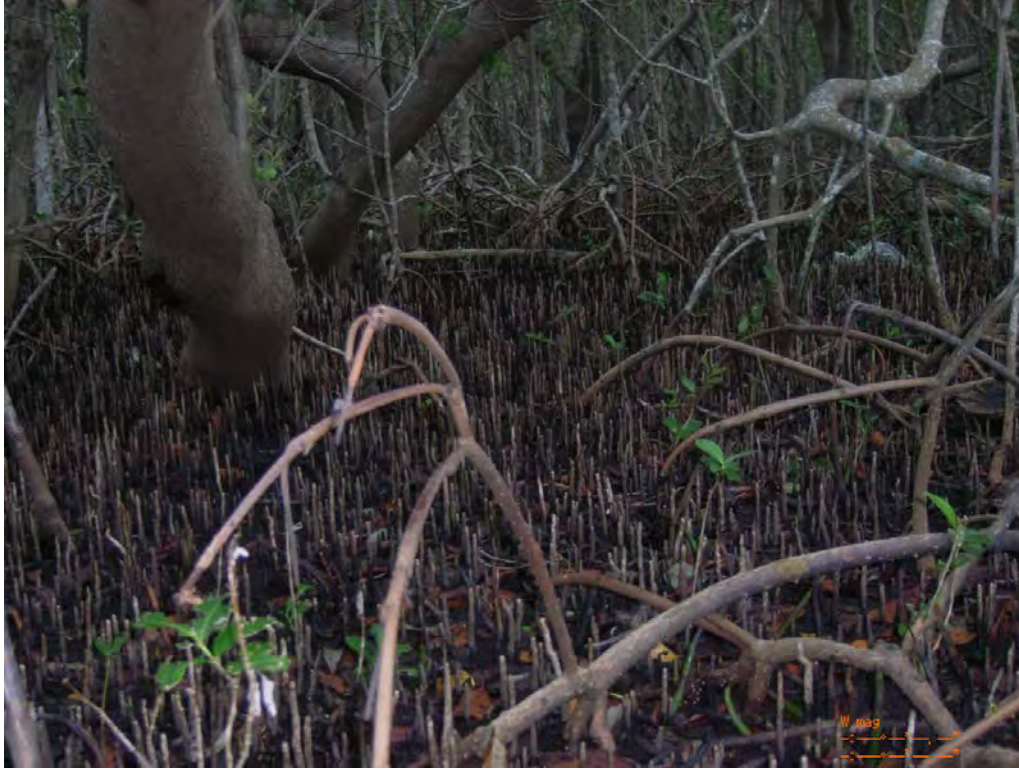
Figure 32: Layering of mangrove cover can reduce the light at the forest floor.

When all species cover is added together, mangrove tree cover averages 82%. The cover within a forest was measured as high as 285% with layering. On a bright and sunny day, these forests can be quite dark at the floor.

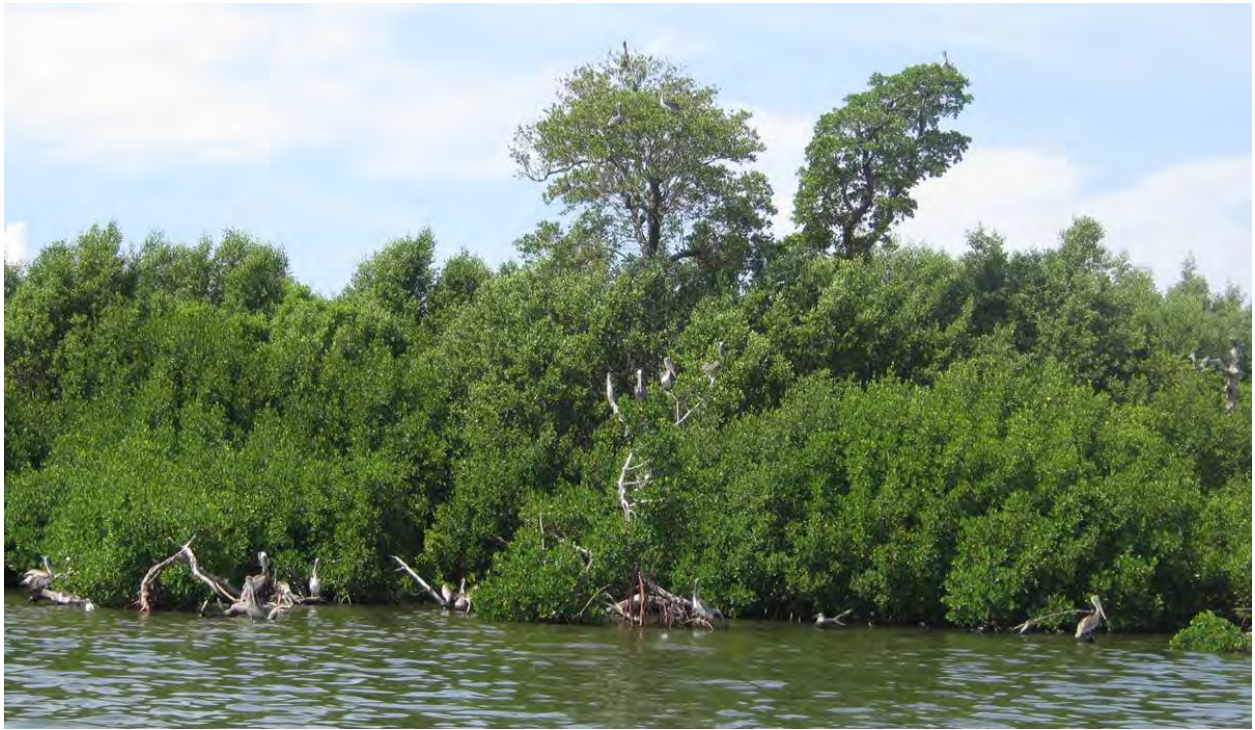
Figure 33: A typical view of the mangrove fringe, with red mangroves at the front and black mangroves towering over.

On average black mangroves tended to be tallest tree species.

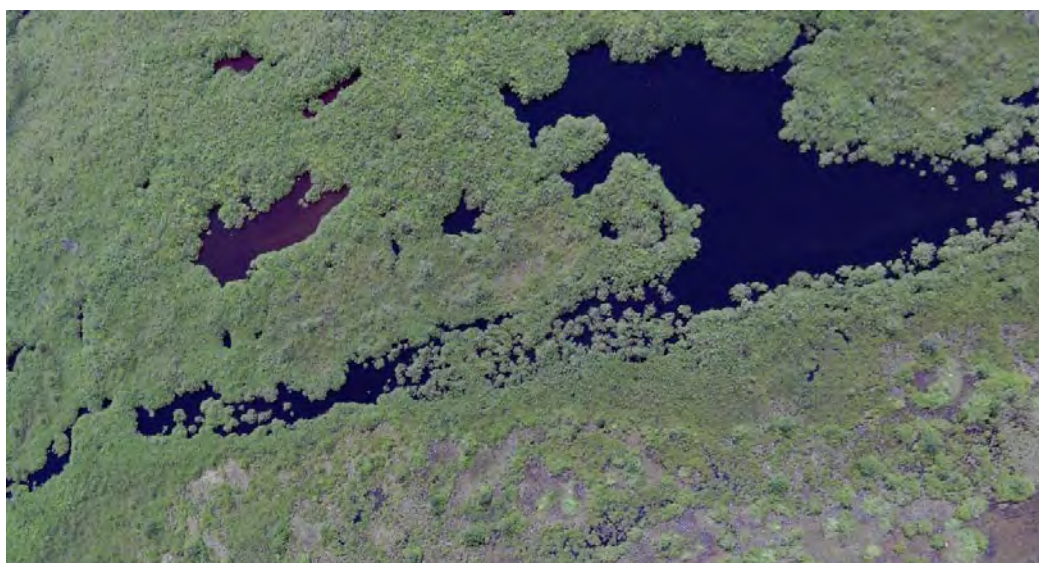
Figure 52: Line of mangroves of declining condition mapped as Fringe but interpreted as Basin (Photo credit: Maj. Dick Morell, Charlotte County Civil Air Patrol)

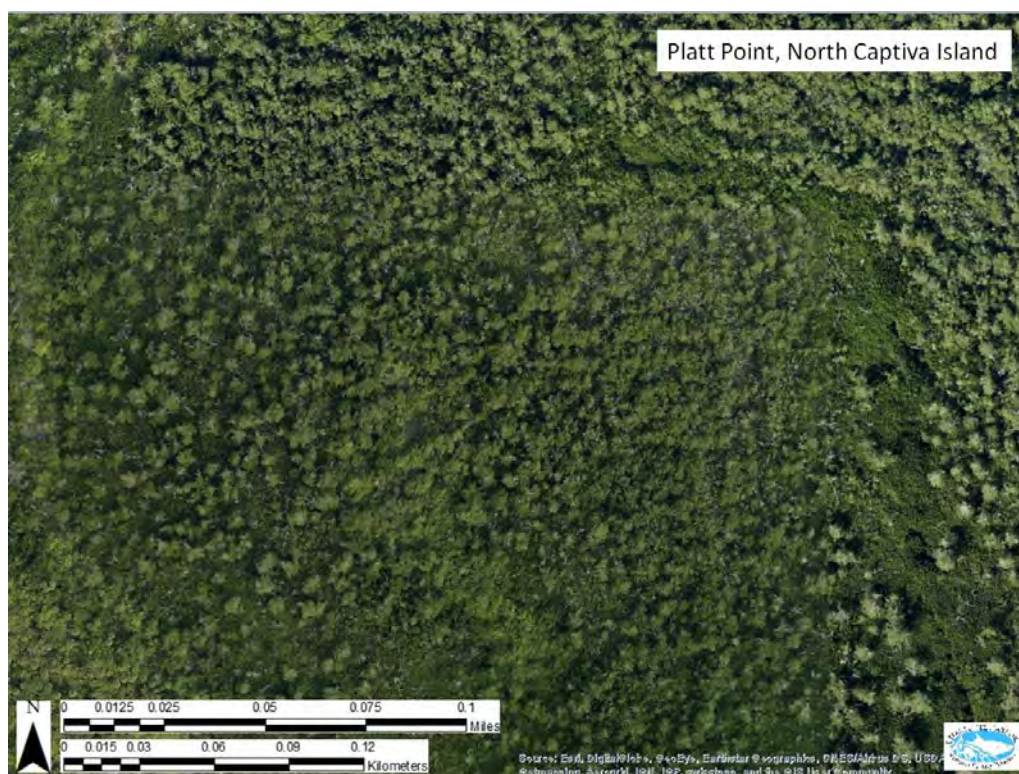
Map 36: NDVIg indicated poor condition that could not be seen on the aerial

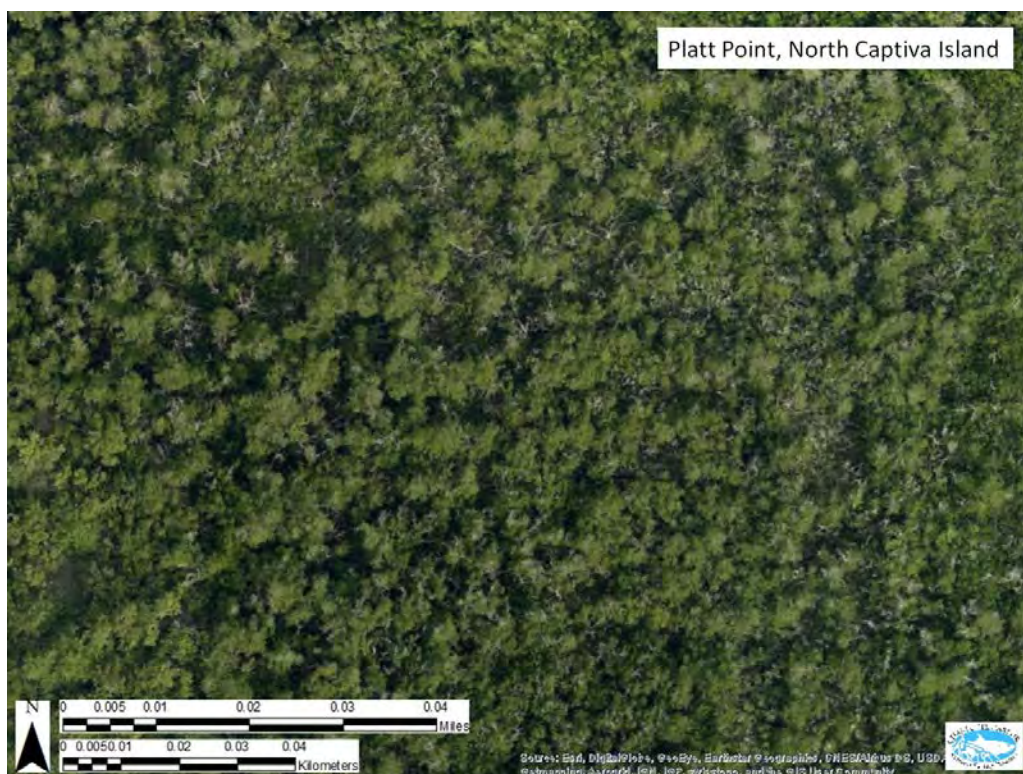
Map 37: NDVIg indicated poor condition that could be seen at 500 scale

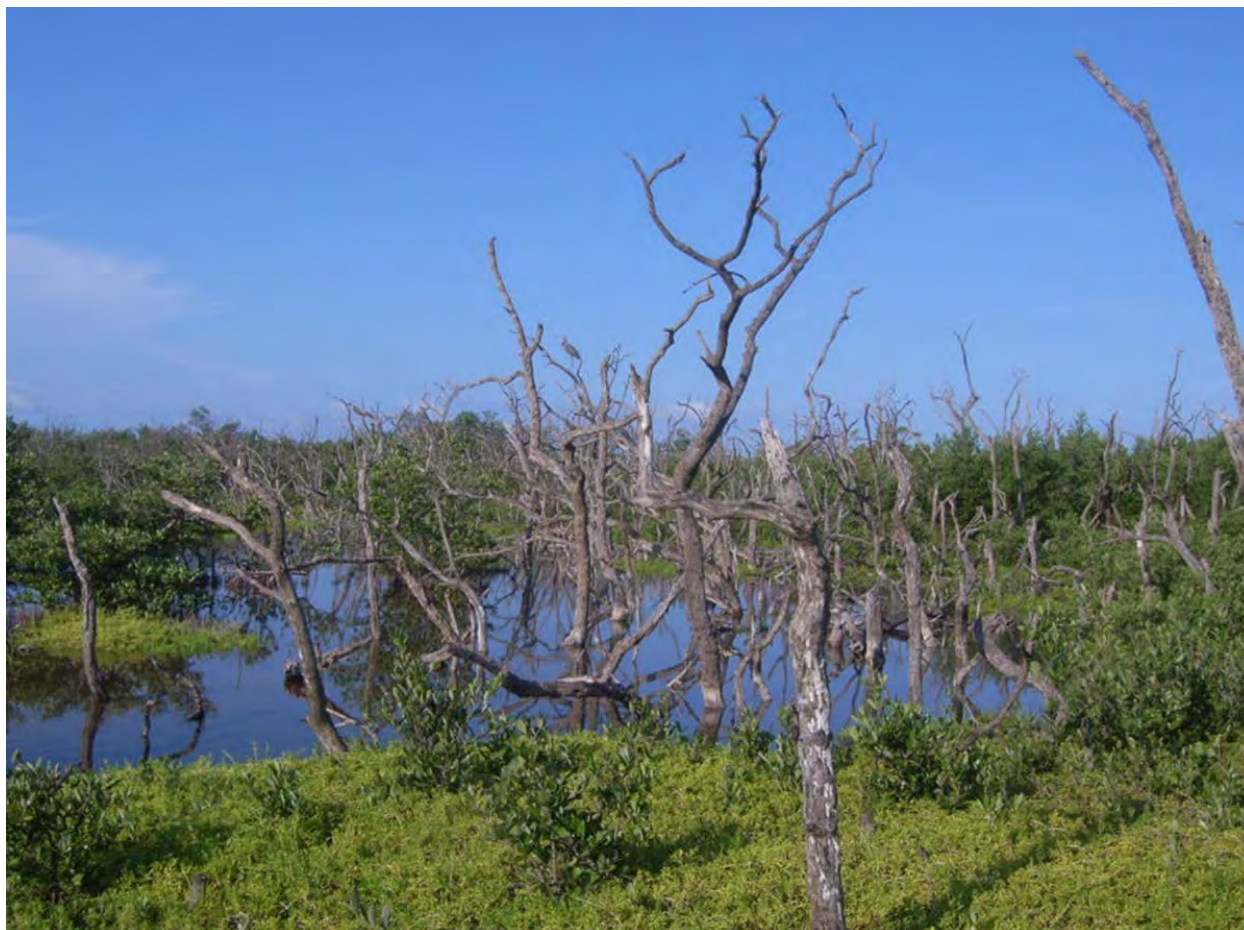
Figure 60: Black Key Basin Mangrove Die-off and Recovery

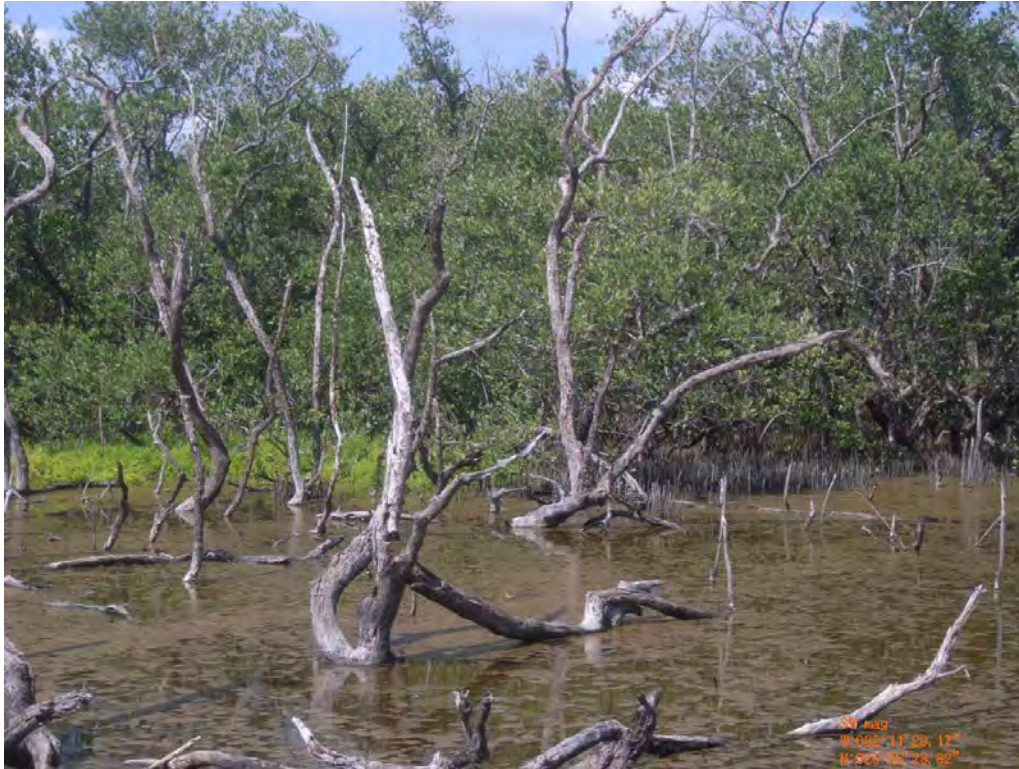
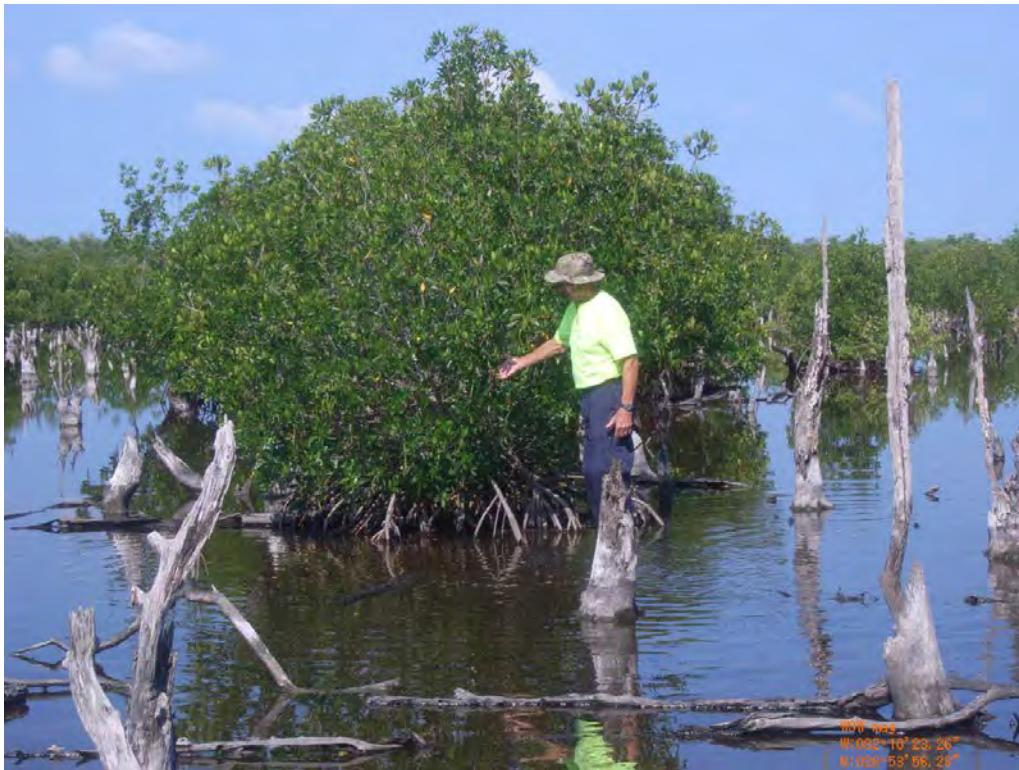
Figure 61: Peat Oxidation and Recolonization of Red Mangrove at Die-off Site
